STS-104/ET-109 Flight Readiness Review

External Tank Project

Cracks in ET-117 LH2 Barrel Panel Ribs

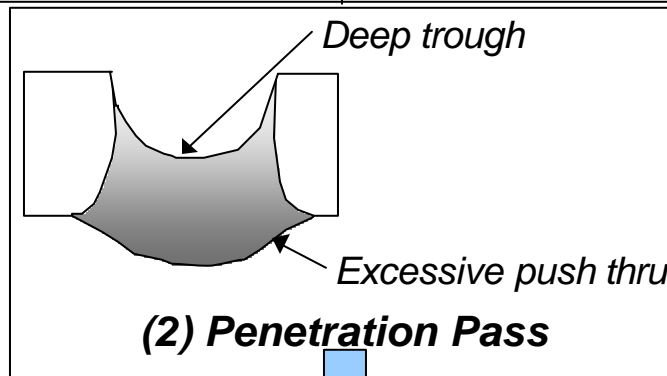
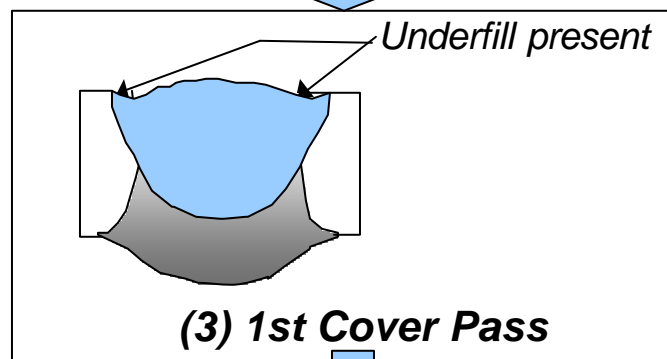
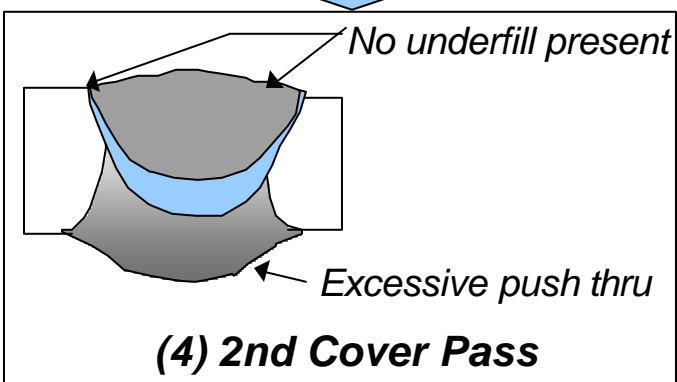
- Non-standard initial weld of LO2 tank dome gore weld ODG-11 resulted in low weld elongation ($\approx 1.0\%$) which drove unique full length repair
 - No parameter violations were noted for any pass
 - Required use of standard 1" and wide panel (18") data to demonstrate repair weld properties

- Sectioned cores from ODG-11 flight hardware for macrostructure comparison to test panels
- Test panel results:
 - Disparity in elongation
 - Some test panels produced 1.5 - 2.0% elongation @ RT and 0.5 - 1.0% @ -320°F
 - Typical initial welds produce values of 4.0-6.0% @ RT and 3.0-5.0% @ cryo temperature
 - Typical repair welds produce values of 4.0-5.0% @ RT and 2.5-4.0% @ cryo temperature
- Evaluated series of repair options to increase overall elongation of weld
- Selected optimum full length repair method
 - Maintained acceptable tensile properties
 - Produced acceptable elongation
 - No reduction in elongation in shaved condition

- *First time full length repair using 4 additional weld beads at initial weld fusion lines*

- Welds are adequately proof tested (assures > 4 mission lives based on standard fracture assessment)
- Proof test demonstrates > 117% of flight limit load based on a strength assessment (temperature corrected)
- Panel testing showed repair met or exceeded design repair weld strength and elongation values
 - Repaired core hole included in test samples

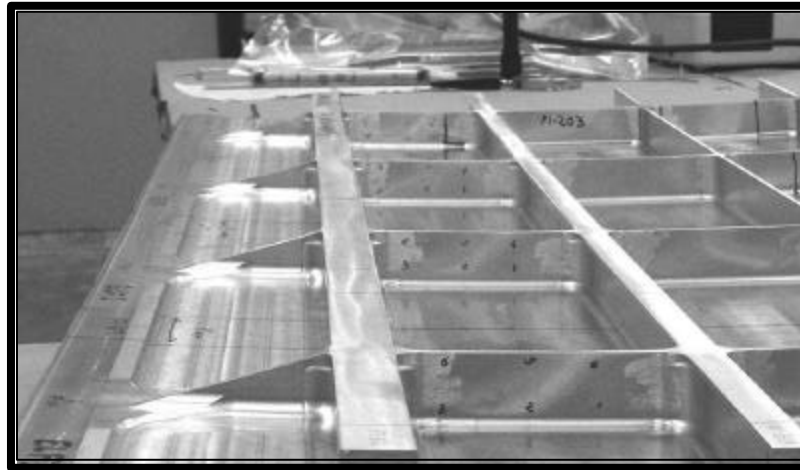
Typical Orthogrid Configuration

- Two cracks were found on LH2 Tank Barrel #3 during the first step of a planned post-proof visual inspection
 - The cracks were on two internal circumferential orthogrid ribs and went through the thickness of the rib and were approximately 1.00" long at the ISL (inner skin line)
 - ISL (inner skin line) observations
 - Cracks were similar in geometry
 - Indicates that ribs experienced similar stress condition
 - Cracks extended into the membrane
 - No other visible damage
 - OSL (outer skin line) observations
 - Dimple noted with visible indication at the rib (C37) location
 - Various minor scuff marks noted in the region of ribs C35 and C37

Crack on rib C35

Crack on rib C37

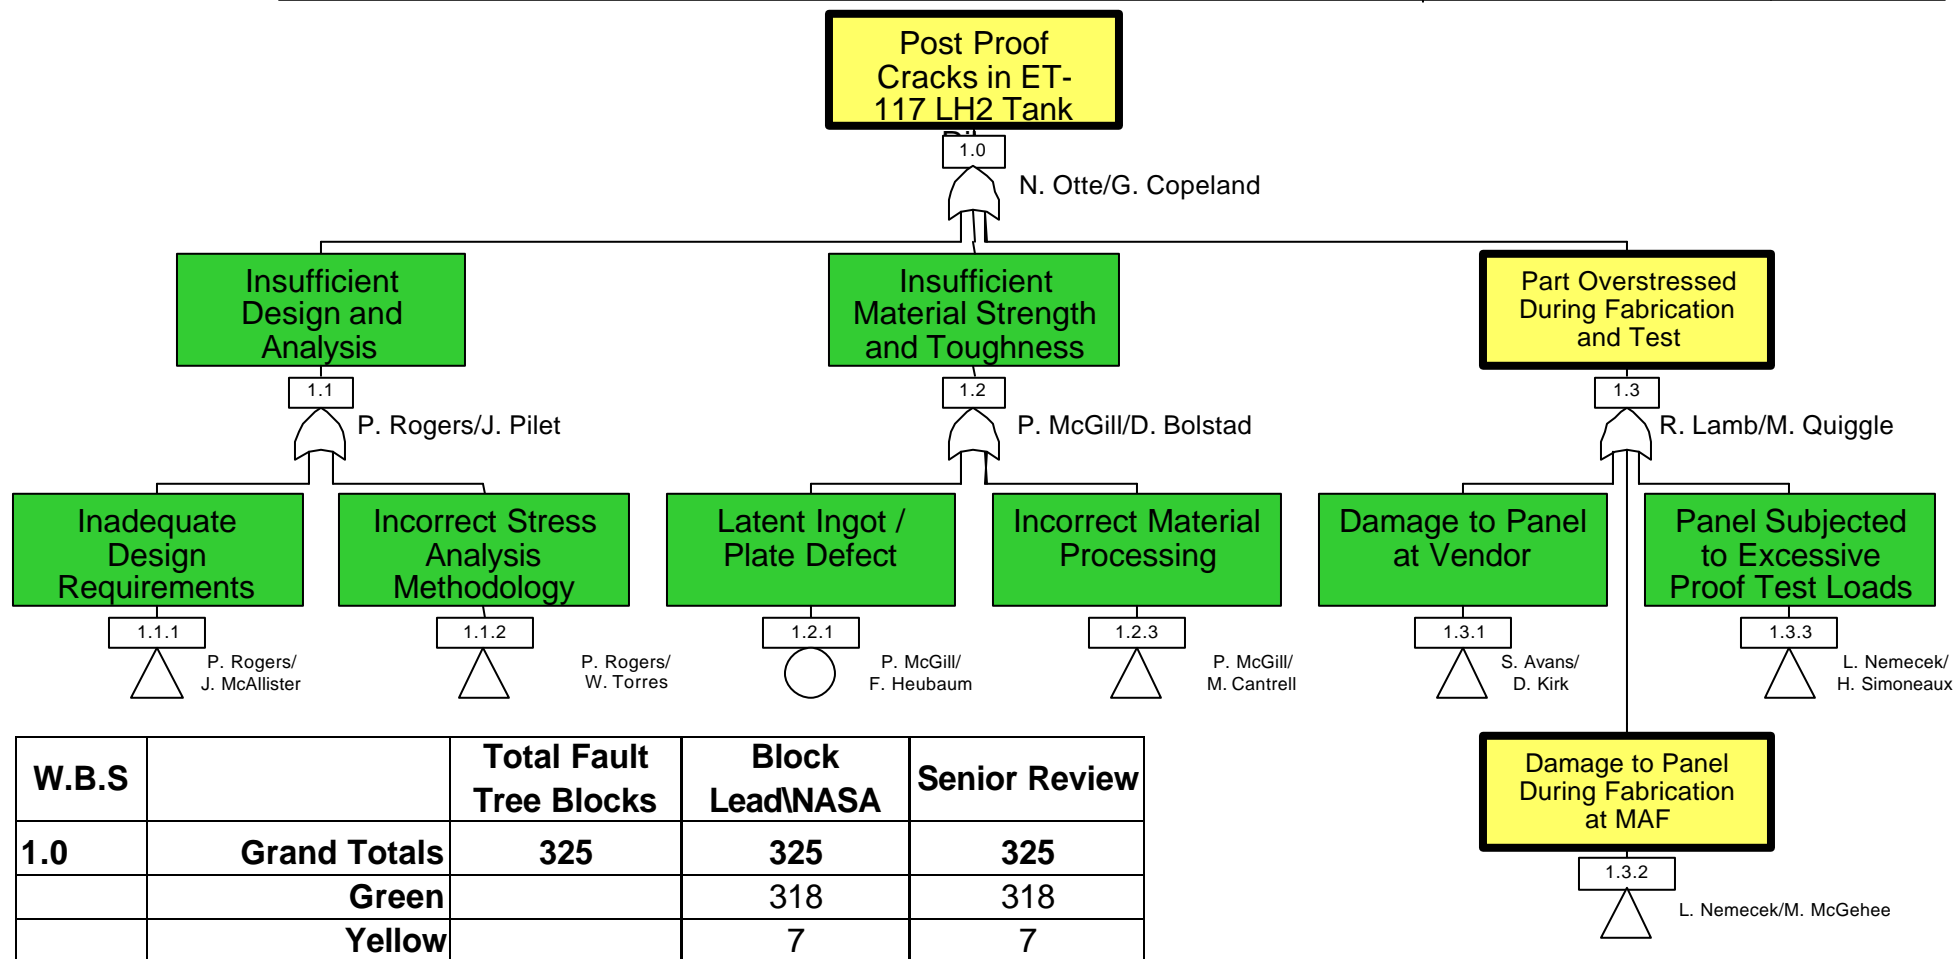
| W.B.S | | Total Fault Tree Blocks | Block Lead/NASA | Senior Review |
| 1.0 | Grand Totals | 325 | 325 | 325 |

Yellow = Indeterminate Cause / or Contributor
